WindTech transforms Vestas V44 wind turbine into V42 for Solvento Energy

The challenge

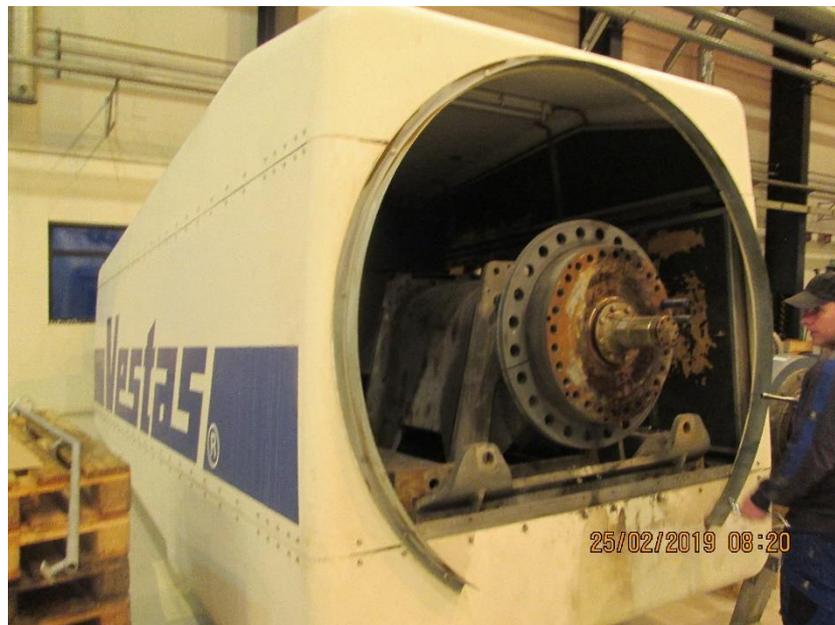
This was the condition of the nacelle when we first received it.

WindTech received the nacelle and its hub in mid-January 2019. According to WindTechs standard procedure, the nacelle was entry-checked for any visual cracks or defects. Afterwards the nacelle was disassembled, and its components cleaned.

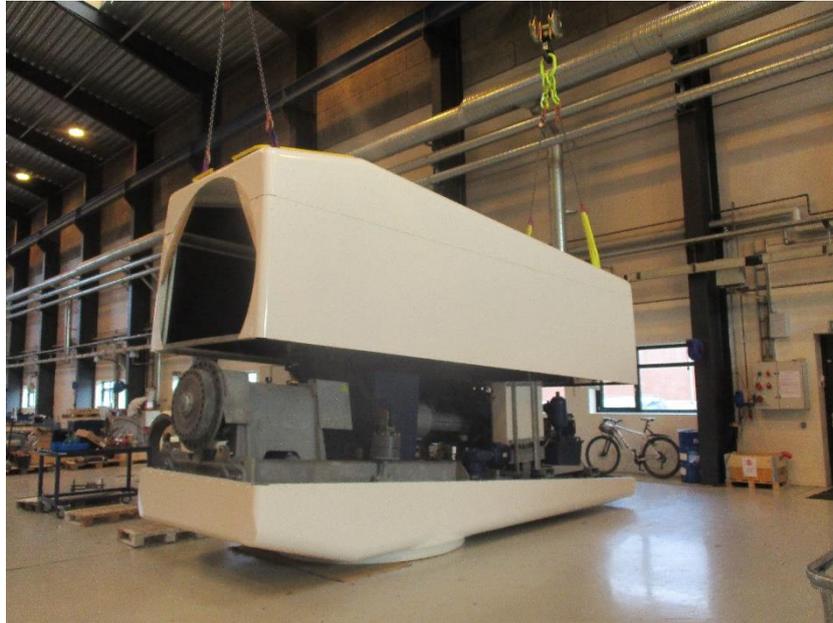
The last touches was put on the nacelle – Now it just needed paint.

At the end of the project, all the components were lubricated and painted. With the components completely refurbished, the nacelle was now ready for to be reassembled. After the exit-check, the nacelle was ready for departure for Navarra in northern Spain.

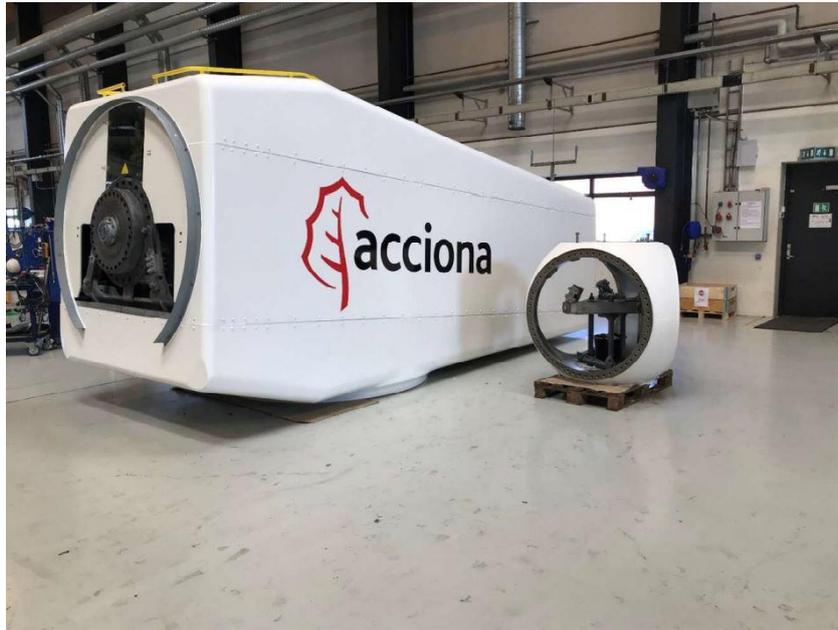
The complete refurbishment of both the nacelle and hub is completed.

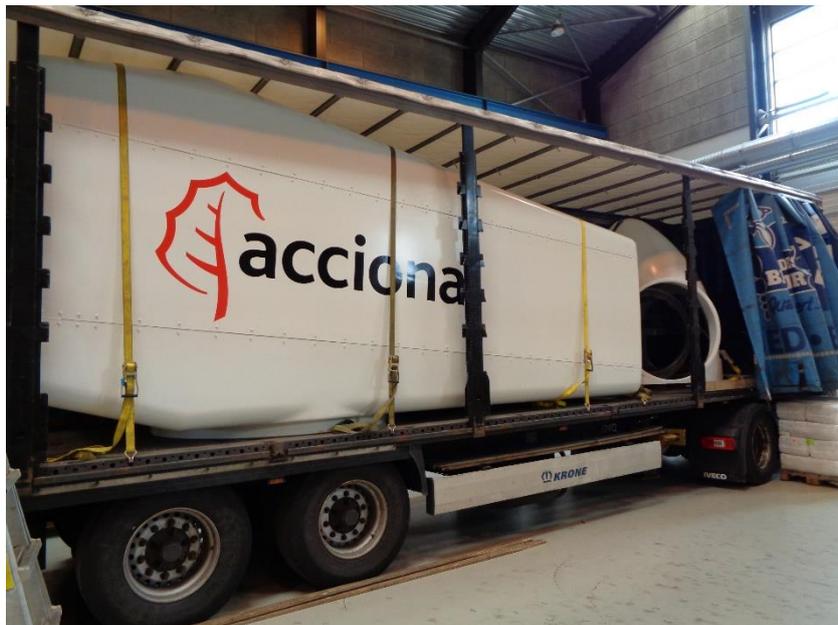
The finished nacelle is loaded and prepared for shipment for Navarra, Spain.
